İZMİT SULTAN ABDÜLAZİZ IMPERIAL LODGE: DOCUMENTATION AND ASSESSMENT OF DAMAGES CAUSED BY THE EARTHQUAKE OF 1999

ABSTRACT:

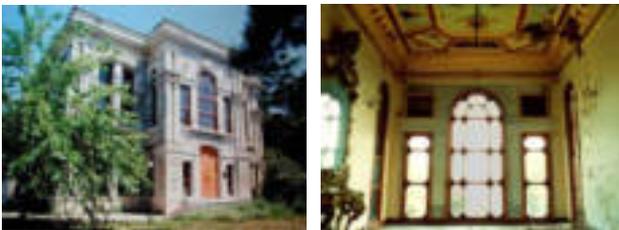
Figure 2a, 2b. Internal and external views after earthquake.

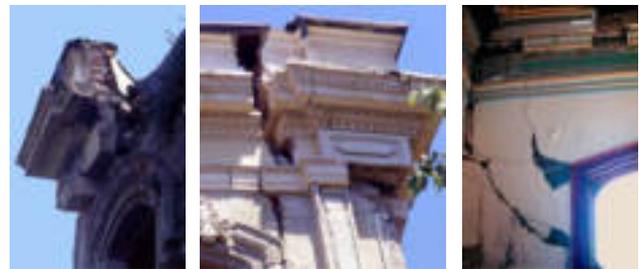
Figure 3a, 3b, 3c. Constructional damages after the earthquake

The most prominent type of deformation in the building is structural and results from the earthquake of August 17, 1999. Inappropriate interventions and lack of maintenance prior to this disaster have intensified its destructive effect. Especially striking is the collapse of the roof parapet in large pieces, which has also brought down the cast iron balcony balustrades with

them. The debris of the roof parapet, cornice and brick masonry wall is collected on and underneath the east facade balcony. The corners of the roof parapet are cracked and split as much as 30cm. The exterior and interior walls of the building bear cracks of various shapes in 0-7cm range whereas some lean as much as 10cm from the vertical.

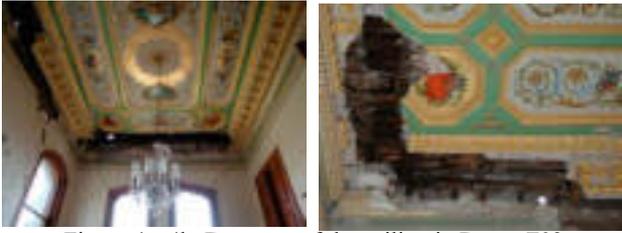
Figure 4a, 4b. Damages of the ceiling in Room Z03

The timber plaster lathing on the ceilings has partially decayed in time; the lack of repair and maintenance and the parts collapsed because of the earthquake have increased the rate of deterioration due to exposure to rainwater, as a result of which the original decoration has been partially destroyed. The roof waters have reached the intermediate floor level as well, causing the swelling of the timber cladding and the loss of decorated plaster on the ground storey ceilings below. The synthetic-based paints used in the latest repair have also caused flaking and loss of the ceiling decoration in large pieces.

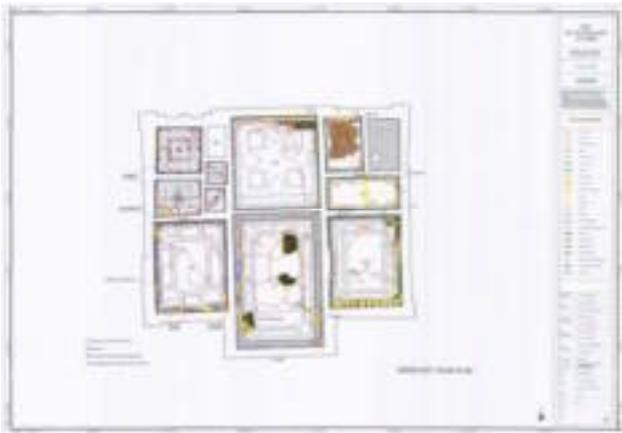
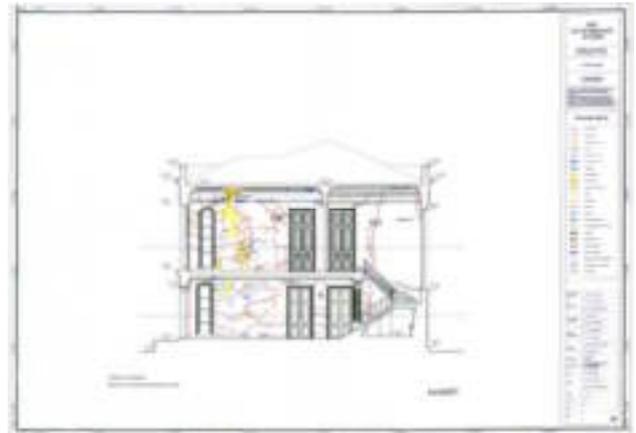
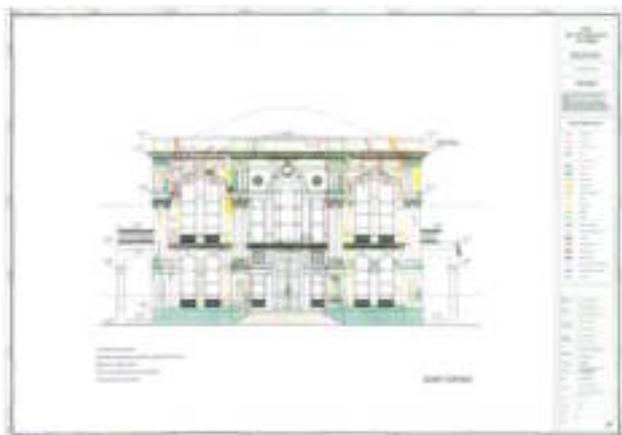
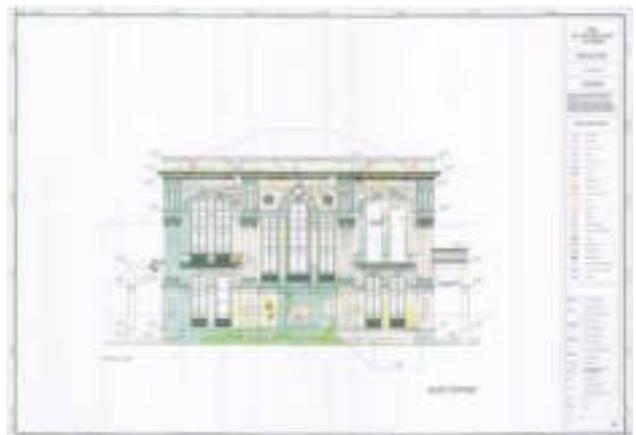
Figure 5a,5b,5c,5d. Damage documentation drawings.

The cracks, collapsed sections and the types of deterioration are indicated on the existing 1:50 scaled survey drawings in mapping format. As a restoration project was required, the defined types of damage were not only indicated on the interior faces visible in the sections but also on additional drawings showing all of the interior wall surfaces. There were cracks of various sizes on the exterior faces and the facade claddings beginning from the roof level parapet and continuing down to the sides of the window openings at different levels. There were additional cracks on the interior walls extending from the ceilings down to the floor levels. As the determination of the size of the cracks would enable the definition of the appropriate type of intervention for their repair, the width, length and depth of all of the visible cracks were measured and indicated on the drawings.

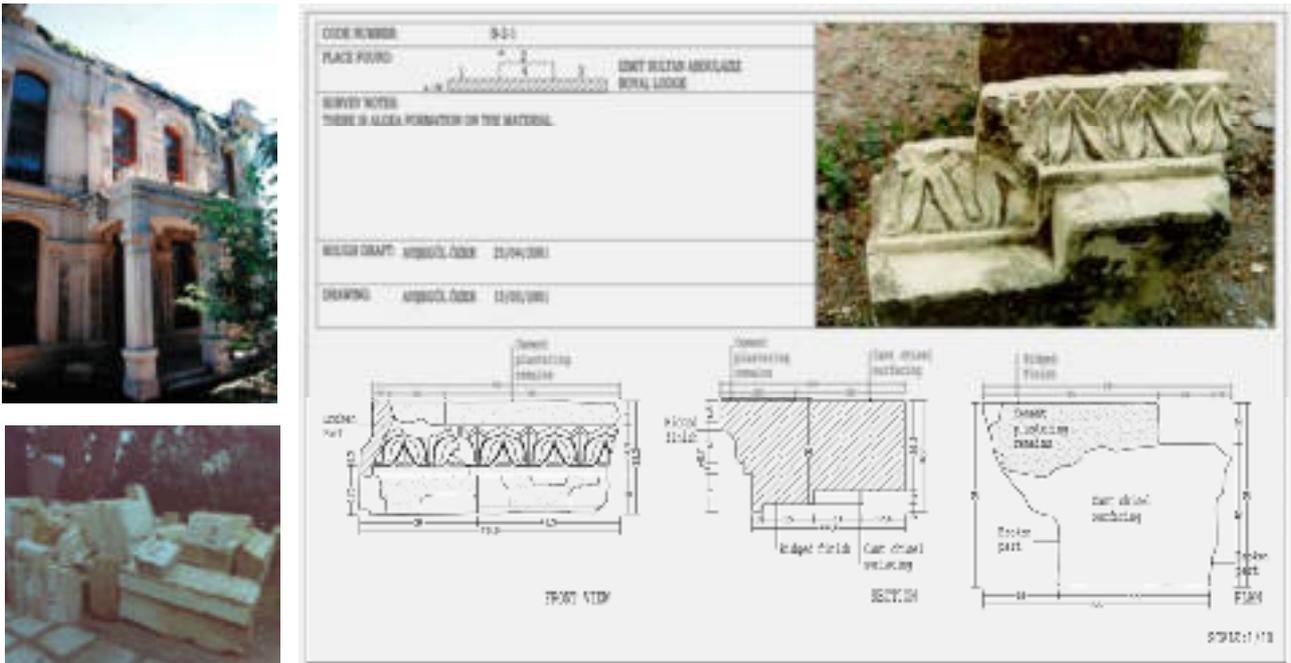
Figure 6a, 6b, 6c. The view of the east facade with collapsed debris of the cornice at roof level parapet and collected fallen pieces in the garden which were classified, numbered and then documented in 1:10 scale detail. A sample of the inventory fiches that were prepared for each of fallen pieces.

The collapsed debris of the cornice from the east facade roof level parapet was collected in the garden. These pieces were classified, numbered and then documented on inventory fiches in detail, showing such characteristics as shape, size and materials, dowel holes and cracks, *etc.*, with the aim of understanding how they could be re-fitted and identifying those which may be re-used in the restoration.

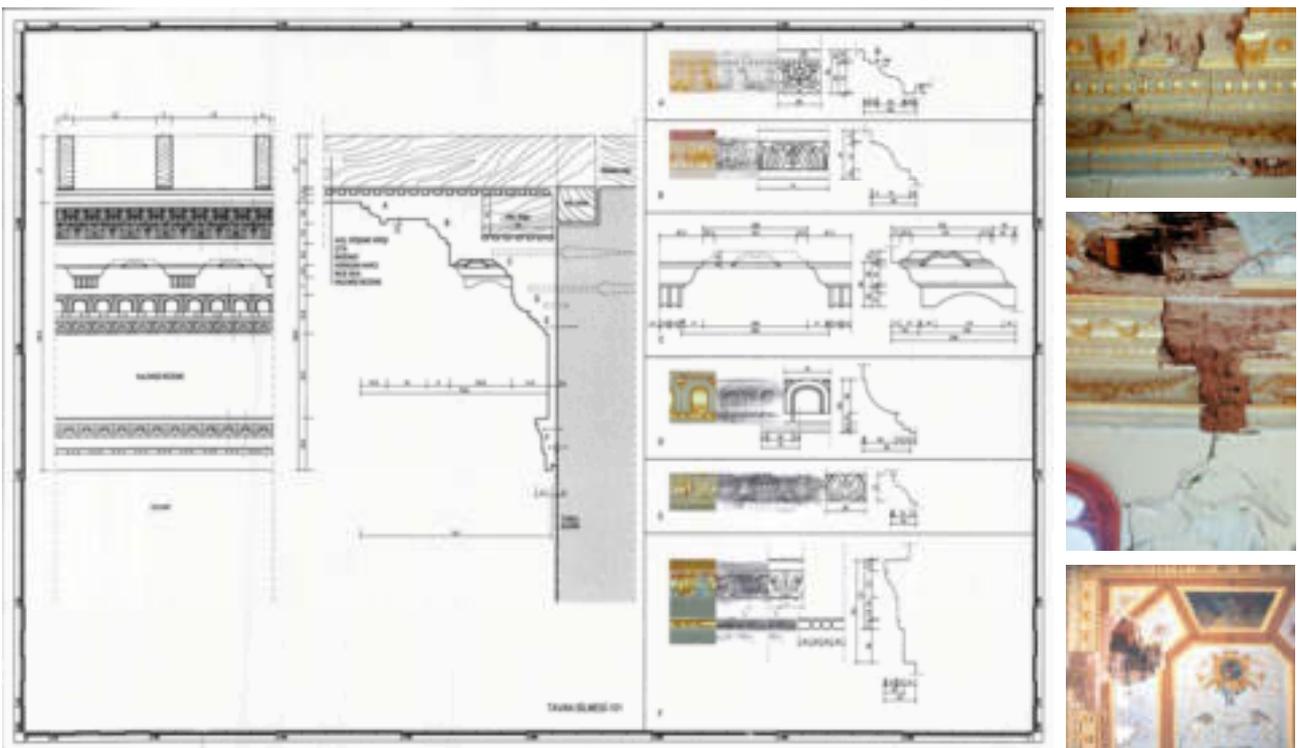
Figure 7a, 7b, 7c. The profiles of the three-dimensional projecting cornices of the interior walls in Room 101. These cornices were documented in 1:10, 1:5 and 1:2 scale. The photos show the severe damage on the cornices and the ceiling.

The profiles of the three-dimensional projecting cornices on the corners of the interior walls and ceilings, which have been severely damaged and were probably to be reproduced were surveyed and documented in detail at 1:10, 1:5 and 1:1 scales, and the decorative elements on them were traced. Their reproduction according to their original shape, size and decorative patterns would be possible depending on this data.
