REHABILITATION OF THE TUNKU CANSELOR HALL, UNIVERSITY OF MALAYA, KUALA LUMPUR, MALAYSIA.

Zuraini M. A.

Department of Building Surveying, University of Malaya, 50603 Kuala Lumpur, Malaysia
zuraini_mdali@um.edu.my

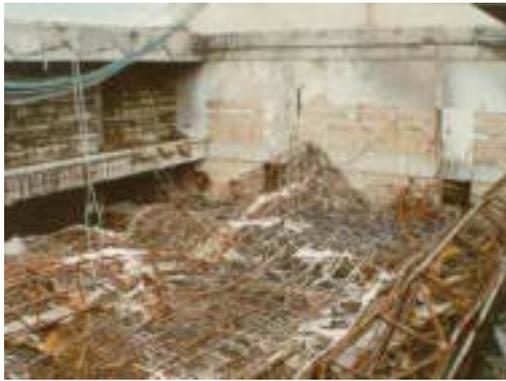
On Friday, June 29th, 2001, a pre-dawn fire gutted the building. Since then DTC had restricted entrance to the public. Almost 90% of the entire internal building was destroyed by fire and fire fighting efforts (See to Figure 2 & Figure 3).

Figure 2: Collapsed roof trusses into the Great Hall

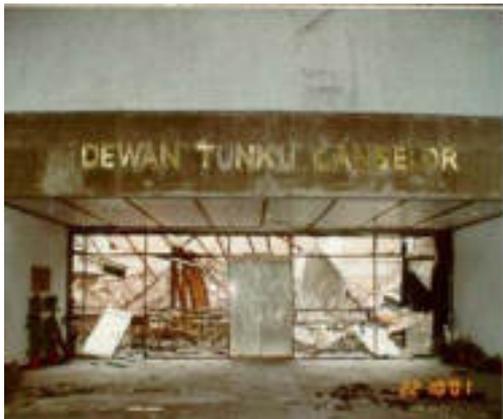
Figure 3: View from the main foyer.

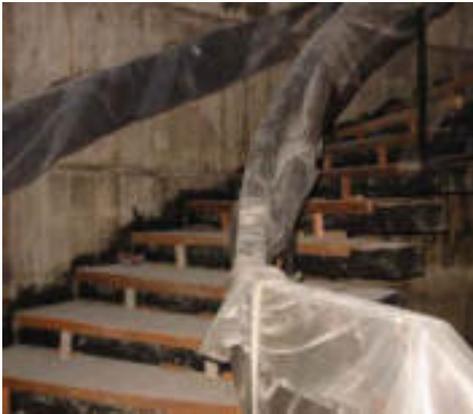
Figure 4: Temporary protection for the spiral staircase

- i) provide temporary protection on the site to ensure that the existing building elements and spontaneous plants were not further damaged during construction. (See Figure 4 & 5)

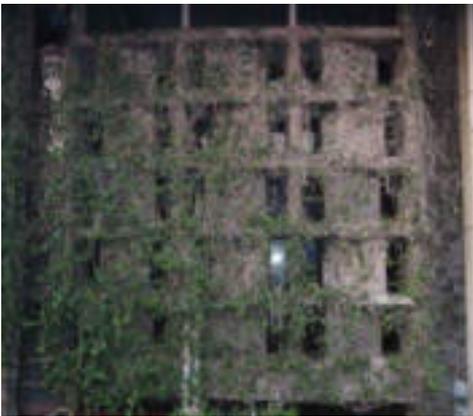
Figure 5: The spontaneous plants on the building facade

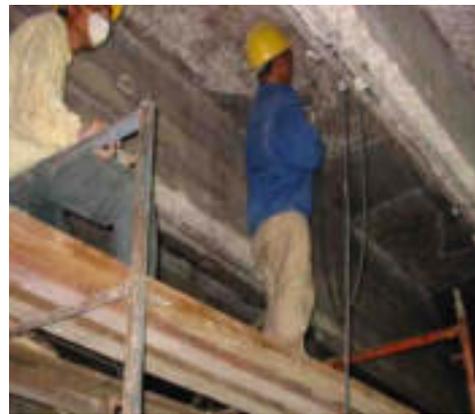
Figure 6: Hacking of the damaged concrete surfaces.

After hacking and repairing the steel reinforcement bar of the concrete and beams (refer to Figure 6), a few layers of bonding agent called ‘Nittobond EP’ were placed to cover the exposed structure (refer to Figure 7). Then the formwork was prepared from layers of timbers line up to produce a textured surface as to its original design. The ‘Renderoc LA Concrete’ was filled up and hardened until the required strength about 60KN was achieved. Once concrete hardening, formworks were removed and surfaces were refined.

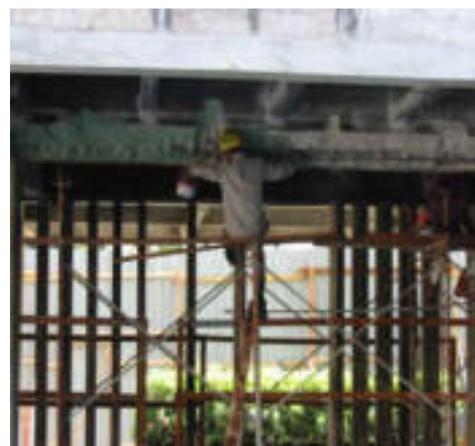
Figure 7: Applying layers of bonding agent Nittobond EP’

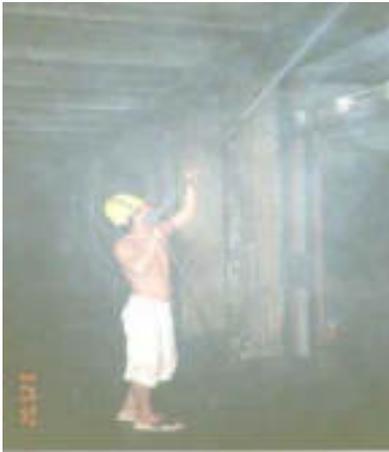
Ninety percent of the existing concrete elements surfaces were covered with soot mark and they required to be cleaned. Appropriate methods of cleaning were used. At the beginning, water jetting system was used to the entire surfaces (See Figure 8). It was found that the soot mark were embedded into the surfaces and difficult to remove especially at certain elements and remote area such as concrete fins, slab soffits, staircases

Figure 8: Water jetting

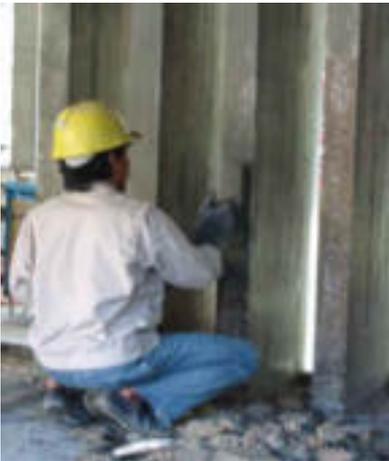
and foyer areas. The second part of cleaning was applied, using scrappers, sponge and a metal hard brush, by scrubbing it manually. Very little Liquid Organic Cleaner (LOC) was used to enhance the process (See Figure 9).

Figure 9: Manual cleaning of soot marks.

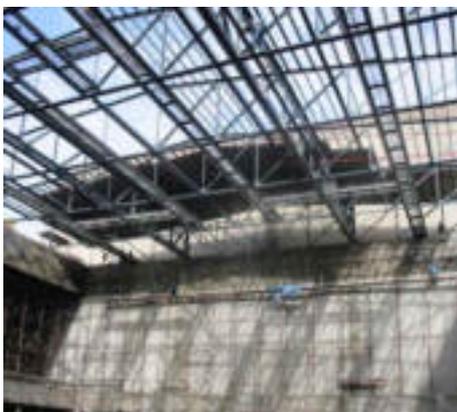
Figure 10: New roof trusses installation

The entire pitched roof over the great hall was replaced with new steel frame and water-proof roof membrane). The design basically reflected the original design with several improvements in terms of acoustic, structural strength and quality (Refer to Figure 10 & Figure 11).

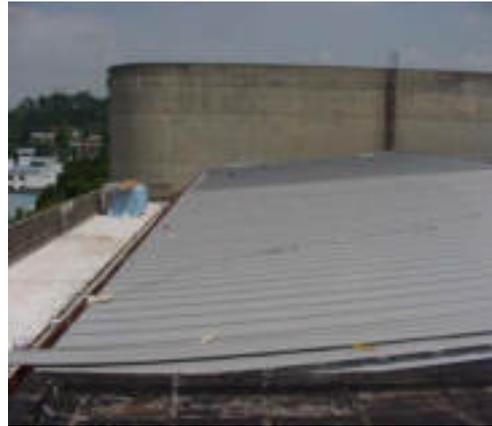
Figure 11: Completed new roof finishes

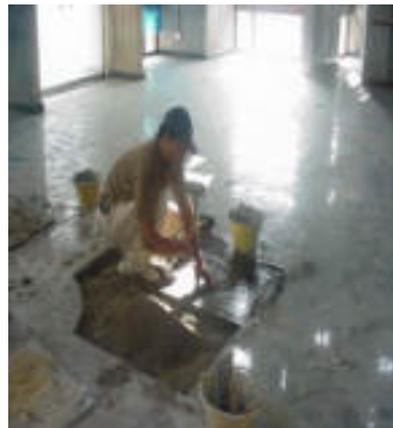
Figure 12: Replacing the broken granite floors.

The important architectural features in DTC were retained and the original design maintained. The main foyer area, the granite flooring, facades and slab soffits, the services and mezzanine level, spiral staircases and concrete handrails were retained (See Figure 12 and Figure 13).

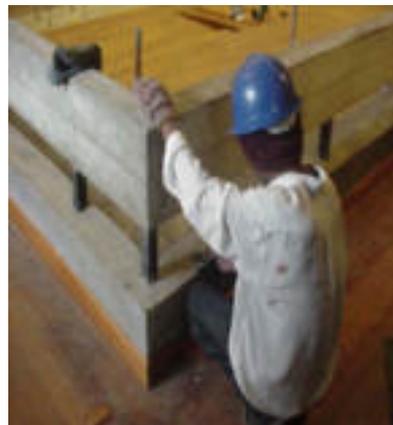
Figure 13: Refining the existing concrete handrails.

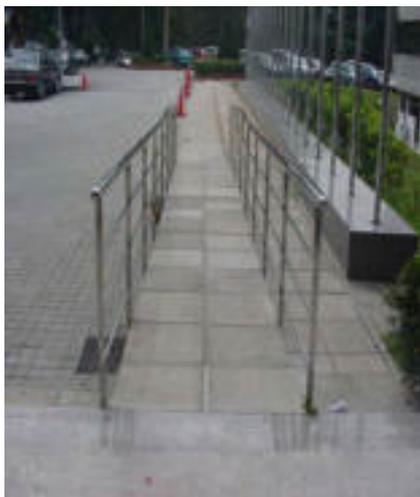
Figure 15: Additional accessible ramp for the disabled.

For the foyer area, the main features were retained with minor intervention of the areas. Improving and repairing works were done including replacing damaged timber framed and broken glass windows and doors, new M&E system with fire protection facilities (sprinklers), repairing the concrete wall finishes and adding new features for exhibition proposes. At the exterior part of the building, upgrading the facilities for disabled and pavements layouts and a new landscaping was designed to complement the building (See Figure 15).
