THE RESTORATION OF BEAUFORT CASTLE (SOUTH-LEBANON) A 3D RESTITUTION ACCORDING TO HISTORICAL DOCUMENTATION

CIPA XIXth International Symposium, 30 September- 4 October 2003, Antalya, Turkey
“New perspectives to save Cultural Heritage”

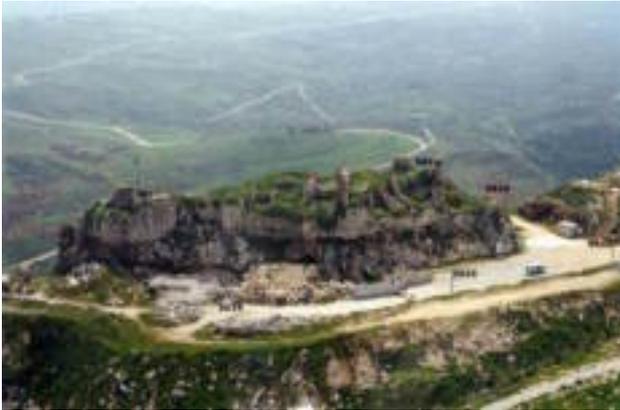
Figure 1. Aerial view of the Beaufort castle (Nikon F3, 2003)

After the end of the war, access to the castle became secure. There was a need to manage to realize a complete documentation of the unreachable parts of the castle (basically the eastern elevation over the valley). That's why a helicopter flight was scheduled in 2003. Aerial oblique views were taken (figure 1) in that flight. They were composed of digital images (Nikon Coolpix 5000, 2560x1920 pixels) and film-based small format color slides (Nikon F3, Nikkor lenses, 55 mm). Last but not least, a complete documentation requested terrestrial views of the castle; digital images and again film-based small format color slides were taken. Thanks to this exhaustive documentation, three-dimensional restitution was possible. All the modern documentation was produced in one day.

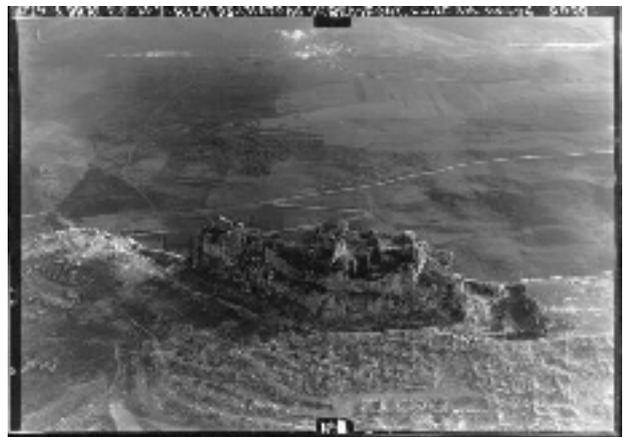
Figure 2. Example of archive photo of 1936 (IFPO), showing in the foreground the archeological hidden remains

b- Serie 2: These are photos still existing in the *Institut Français du Proche-Orient* (IFPO) archives (figure 2). All these photos were taken by the French air force of the *Levant* between the years 1930 and 1936. We were able to get duplicates (contact prints) of the original negatives. They were then scanned.

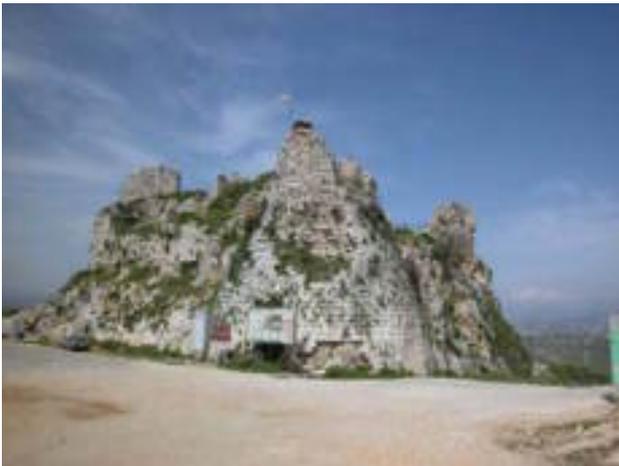
Figure 3. Example of modern photo (Nikon Coolpix 5000, 2003)

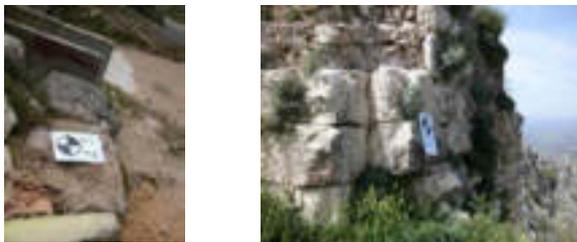
Figure 4. Examples of targets used for the reference points

On that same day, while photos were being taken, a team of geodetic surveyors installed reference points on the ground and elevations of the castle. These points (figure 4) were easy to identify on the photos. A total-station was used by the surveyors to measure the reference points. This generated three-dimensional coordinates for these points.

More than 130 images were realized in spring 2003 with the Nikon F3 and Nikon Coolpix cameras (a hundred images on the ground and about thirty in the helicopter). A first block of 18 oblique views of the castle was oriented in June 2003 using the control points materialized on the ground by targets (figure 4). Standard deviations of about 10 cm on the co-ordinates of the points measured on the images have been obtained. We then selected in this project ten visible points simultaneously on the images of 1931-1936, in order to define approximations of the photogrammetric parameters, and to calculate a block based on a selection of these archive images.

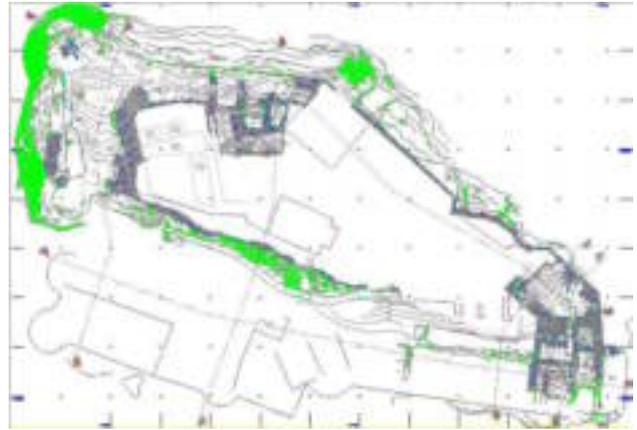
Figure 5. Example of 2D AutoCAD map from the tacheometric survey of 2002 (level 4 of the castle).

The first topographic surveys conducted during the preliminary study were not very accurate due to the difficulties encountered in trying to access some of the areas of the castle. These first surveys were performed using GPS and tacheometric techniques. The AutoCAD maps (figures 5 and 6) used to establish the tender documents for the restoration of the castle

From the block of images previously oriented, the restitution initially carried out in 2D in Autocad (e.g. fig. 5 and 6) will be enriched by a 3D restitution corresponding to the objectives of the documentation. We are then able to calculate and draw the visible structures on the aerial and terrestrial photographs of 2003 by digitalizing on the images (fig. 8).

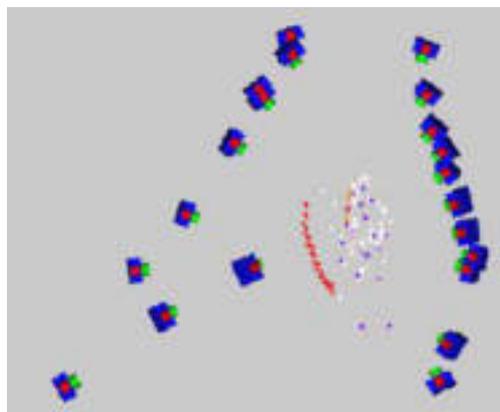
Figure 7a. Overview of the camera stations and the block configuration after the exterior orientation

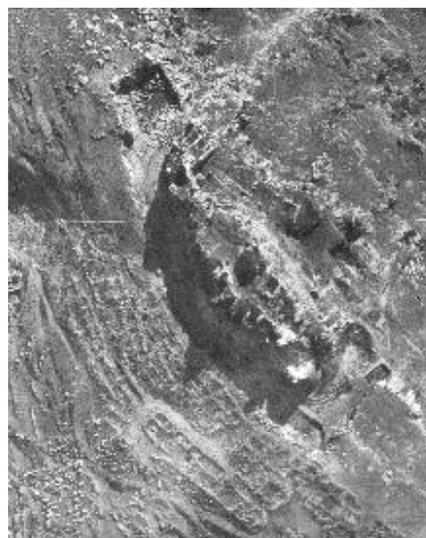
Figure 7b. Aerial view of 1935, allowing to locate the camera stations of the figure 7a

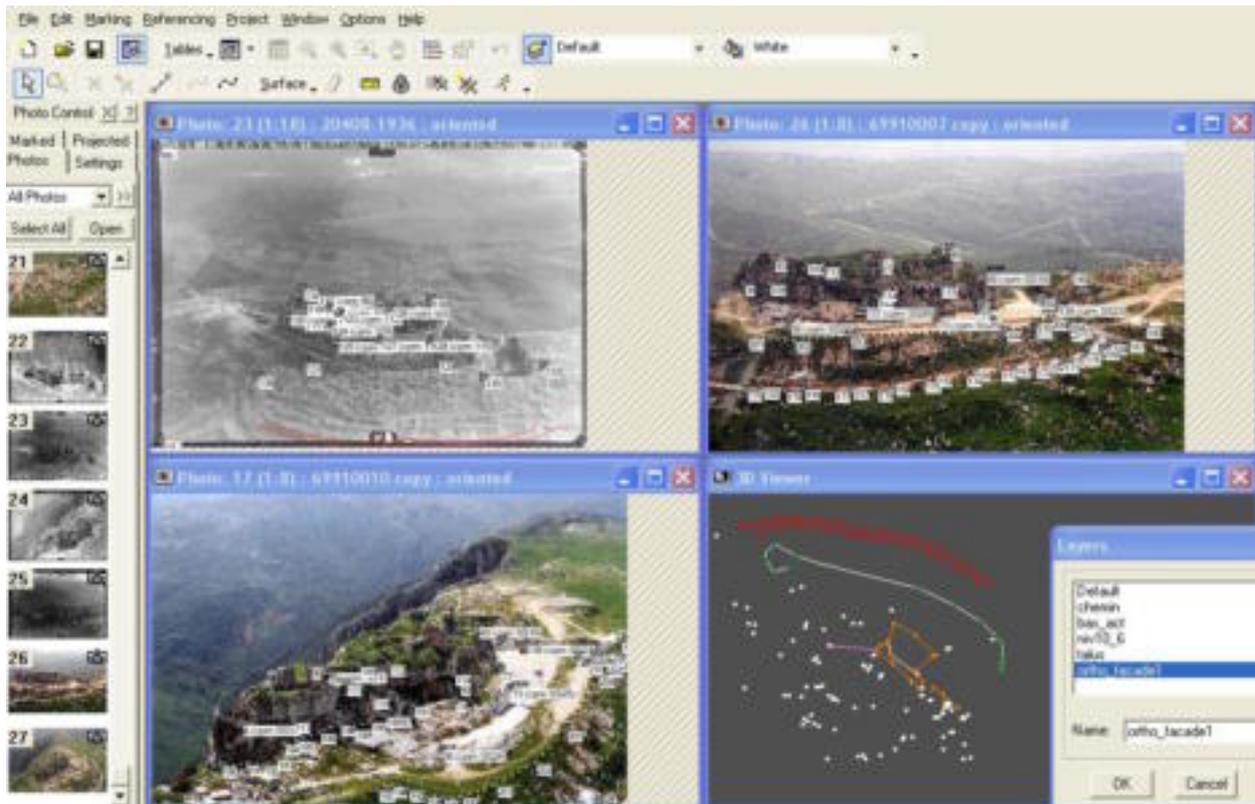
Figure 8. Multi-image restitution within PhotoModeler 5.0

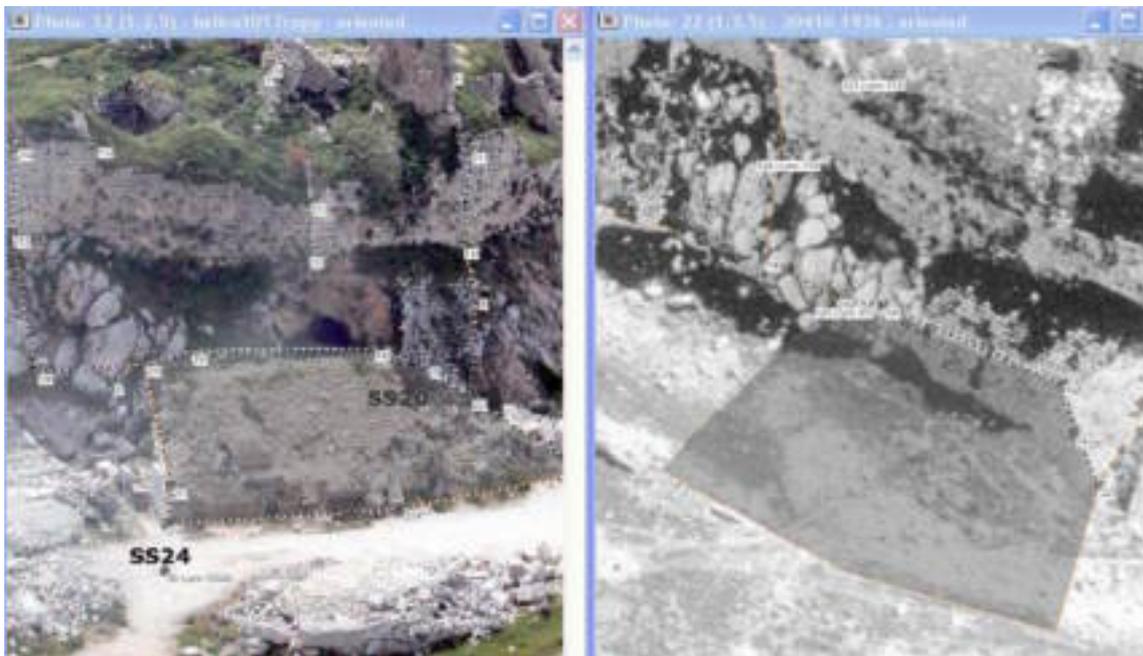
Figure 9. Restitution of the embankment areas.

On the left, the boundary of the embankment is marked on a photo of 2003 and on the right, the corresponding surface is projected on an archive photo of 1936

One will proceed in an identical way on the archive photographs to measure the archaeological structures currently covered by the remains of the war, or to plot in 3D parts of the castle currently embanked or destroyed (fig. 9).

The superposition of the two restitutions make it possible to highlight the areas of interest (figures 9 and 10) for archaeological work and to estimate work of civil engineering (fill, cubature, rebuilding, etc). Moreover, the restitution of the site in wire frame and surface model can be supplemented by the addition of textures

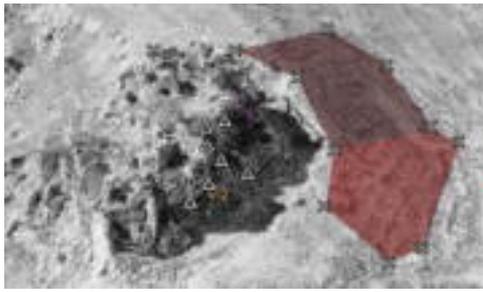
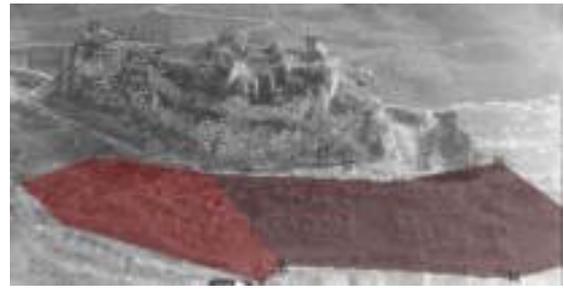
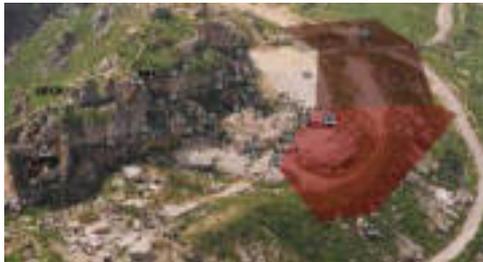
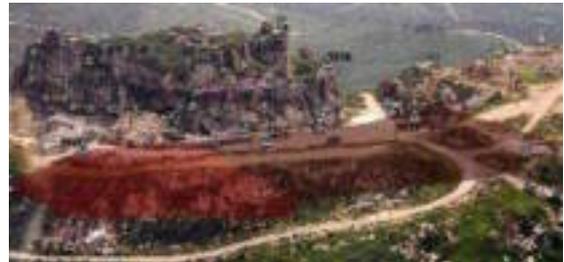
Figure 10. Archaeological structures are measured on the archive images of 1936 and the corresponding surface is shown on the photos of 2003

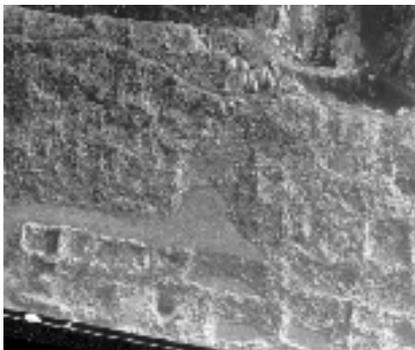
Figure 11. Example of orthophoto of the archeological structure (computed from archive images)

coming either from the images of 1936, or of those of 2003. From the resulting 3D photomodels, orthophotos can be calculated for the two periods, as e.g. for the frontages of the castle or the installations around the site covering the archaeological structures (fig. 11).
