REVITALIZATION OF A STREET IN A HISTORIC URBAN QUARTER : CASE STUDY: GİRNE LİMAN ARKASI

B. Oktay^a, M. Faslı^a, N. Paşaoğulları^{a*}

^a EMU, Faculty of Architecture, Famagusta, T.R.N. Cyprus - (beser.oktay, mukaddes.fasli, nil.pasaogullari)@emu.edu.tr

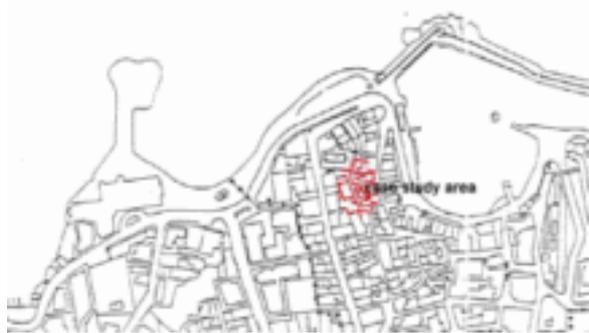
Figure 3. Plan of the case area

In general, city center mainly composed of two historic urban quarters: Türk Mahallesi and Liman Arkası. These two historic urban quarters reflect the characteristic features of these different cultures, which are the components that constitute the cultural heritage. The district located between the medieval castle and the main commercial street called "Liman Arkası" and selected as a case area for this paper. It is a kind of buffer zone between the new developments and the harbour (Oktay, 2000) (Figure 3).

This area composed of narrow organic streets that are defined by attached buildings where still keep their spatial quality of human scale and the local identity. The new developing districts of the city have a contrasting layout to the urban pattern of this area that makes Liman Arkası unique in the city scale.

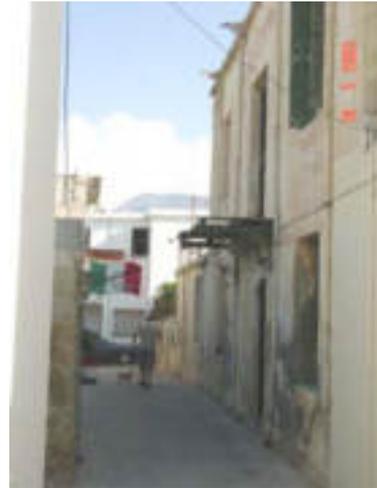
Figure 4. A view from the street

The case area is a narrow pedestrian street. It is strongly defined by continuous building blocks that are mainly housing. Street itself is a meeting place that extends itself into the house at ground floor level. People carry out their sitting room into the street; they sit into the street and keep their doors open to watch the outside. The traditional buildings along the street are in human scale. There is a slight fluctuation on skyline properties. The buildings along the street have no unity problem. The units are mainly used for accommodation of the residents, only two of them are used for touristic and recreational purposes. One is used for art workshop and the other is used as restaurant. The base covering of street is parquet. There is no adequate street furnishing and landscape along the streets (Figure 4).

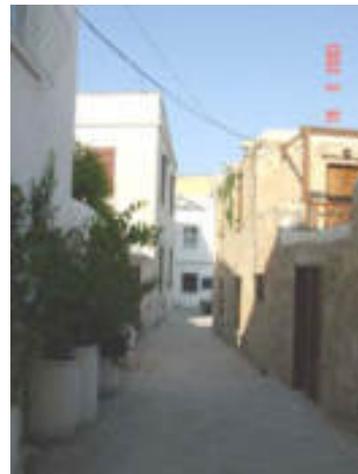
Figure 5. Houses and courtyards

When the street is analysed in unit scale, it is seen that, it is dominated by traditional houses. Some of the traditional buildings are physically in poor condition in terms of facade, architectural detail and structural system. The houses along the street have one or two storey height. They were constructed by load bearing system. Stone is the main construction material. They are continuously located along the streets. Each house have a small courtyard at their side or back. Each courtyard has a number of fruit trees in them. Main entrances are generally given from the middle of the front facades. Some of the houses have a small front balcony that is the characteristics of the British architecture in Cyprus around at the beginning of the 20th century. They have flat roofs. Timber works were used for doors. Generally the doors have two wings. Vertical windows were designed for them that were screened by timber shutter (Figure 5).

- Poor building façades including windows, balconies, roofs and walls;
- Buildings in poor structural condition;
- Buildings with lack of maintenance;
- Poor conditioned building courtyards;
- Lack of landscaping features and urban furniture;
- Base covering of both street and the neighbouring square;

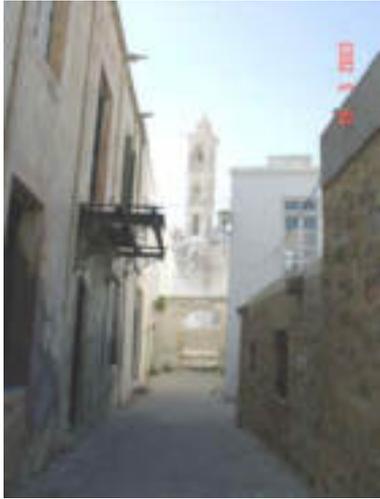
Figure 6. Street view towards the church

The street is opened to a nice defined square with an arch. The square is dominated by a white church that is very harmonious with its environment (Figure 6).

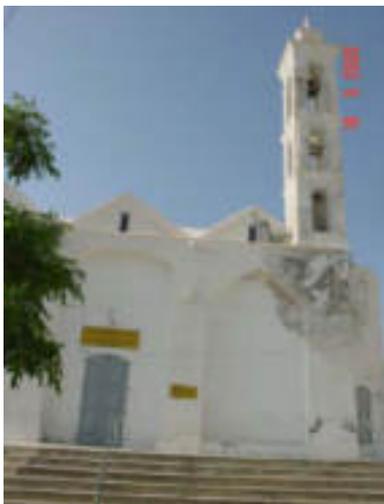
Figure 7. Icon Museum

It is used as Icon Museum. All of the outdoor space covered by hard surface and it is unbearable during the day, because there is nine months summer in Cyprus (Figure 7).
