THE RESTORATION OF SUFFOLK HOUSE, PENANG, MALAYSIA

KEY WORDS: Building survey, documentation, restoration

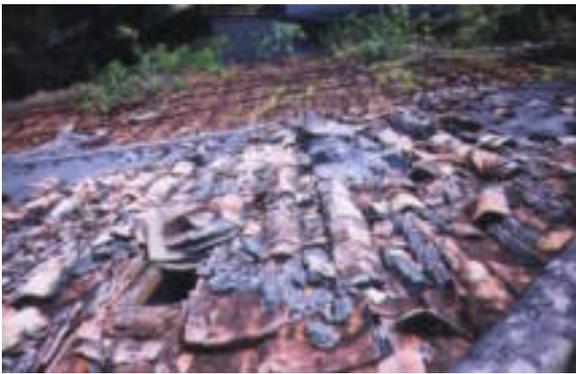
This is the major problem to the house. The roof is badly leaking and generally in poor condition. Most of the roof tiles were broken and falling down. Some of the roof structure such as timber trusses and rafters were rotting and infected by termite. The slipped roof tiles also have causing water penetration through roof to ceiling areas. The ceiling was facing a serious wood rot and ceiling board getting moist and deteriorated.

Figure 2. The leaking roof

1. Removal of dirt, fungal and harmful growth on wall and column.
2. Dismantling roof tiles and storage the salvage.
3. Cover the roof structure before started restoration works.
4. Removal of any rotten timber trusses and ceilings.
5. Reconstruct the central Jack Roof
6. Laying new clay tiles
7. Fixing water proofing membrane to roof
8. Remove and replace the badly decayed timber floor
9. Hack off the crumble plaster
10. Re-plastering and painting the wall with lime wash
11. Reconstruct the collapse and damage column to the original form
12. Remove and re-pointing loose mortar on the exposed bricks.
13. Restoring any decayed door, window and fanlights
14. Laying and fixing new marble floor

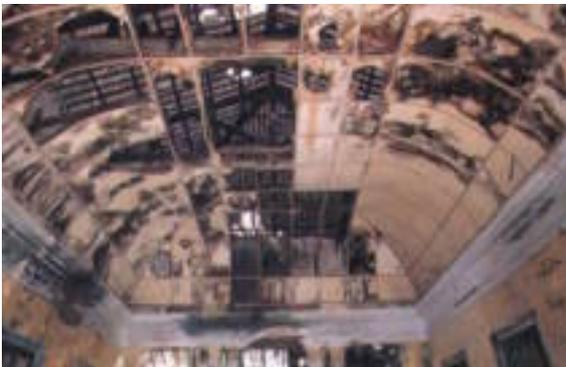
Figure 3. Ceiling board was damaged cause by water penetration through leaking roof.

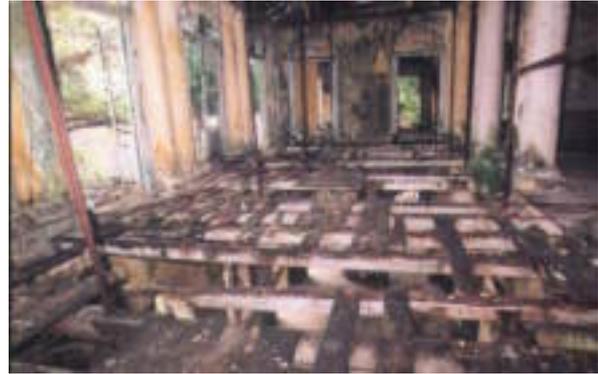
The floor was in poor conditions. The timber floorboard at first floor was rotten and prone to water penetration and termite attack. The damage floorboards were falling down to the ground level and damage the marble floor.

Figure 4. The damage floorboard

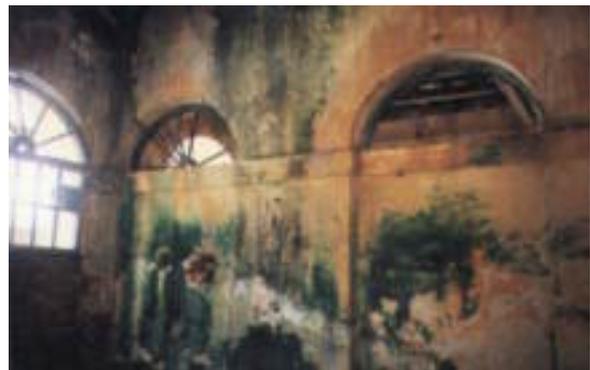
All walls in the Suffolk House were made of plastered bricks, which were painted with lime wash. Most of the wall surface was in poor conditions including peeling plaster, fungal growth, fading lime wash paint and effects of air pollution. The walls and column are not only affected from rising damp but also from moister that seeps through the roof. Most of the wall plaster was crumbling and many surfaces have either no plaster left exposing the bricks and mortar joints.

Figure 5. Wall surface covered with fungal and mosses.

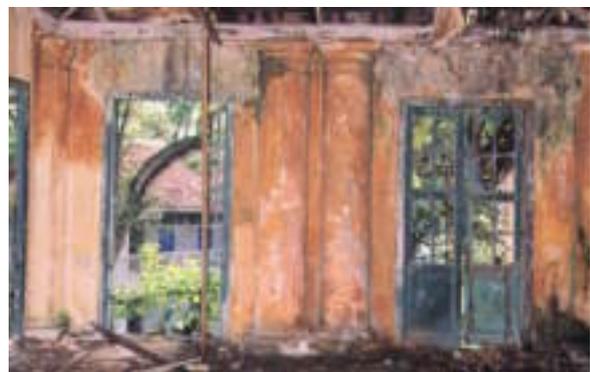
Figure 6. The upstairs building condition, timber door was rotten and damage. The columns were mostly effected with rising damp and crumbling plaster problems.

Rising damp problem was affecting all wall and columns. The rising damp problems is effecting so bad that moisture had not only risen to the ground floor but also up to the first level. Despite the weathering and structural problems, the rising damp was appeared due to the poor drainage system. The lack of proper and efficient water outlet from the building and surrounding area, and high water table have caused the rising damp problems to the buildings. The wet condition of the building and the surrounding area has encouraged the impregnated plants growth bigger near the wall and caused the cracks to the brick walls.

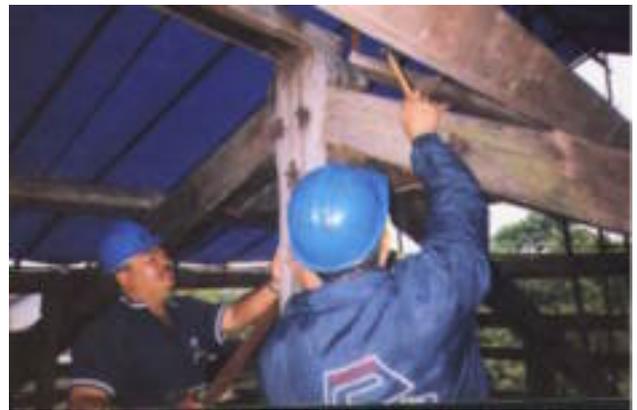
Figure 9. The Inspection of roof structure

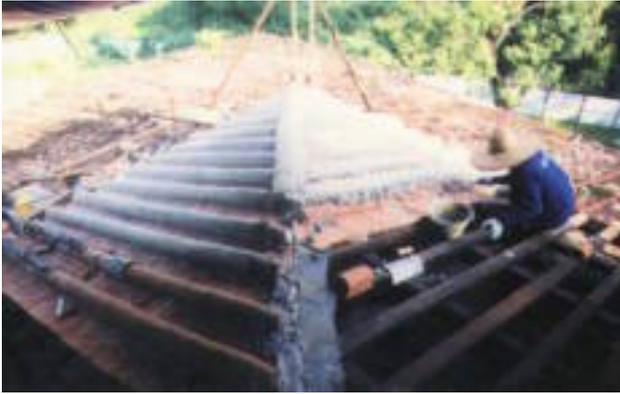
Figure 10. Laying and fixing new roof tiles
