PHOTOGRAMMETRIC RECORDING AND EVALUATION OF THE MARKET GATE OF MILETUS FOR ARCHITECTURAL HERITAGE CONSERVATION

KEY WORDS: Photogrammetry, Close Range, Data Acquisition, Cultural Heritage, Architectural Heritage Conservation, Archaeology, Damage Mapping, CAD, Pergamon Museum, Market Gate of Miletus

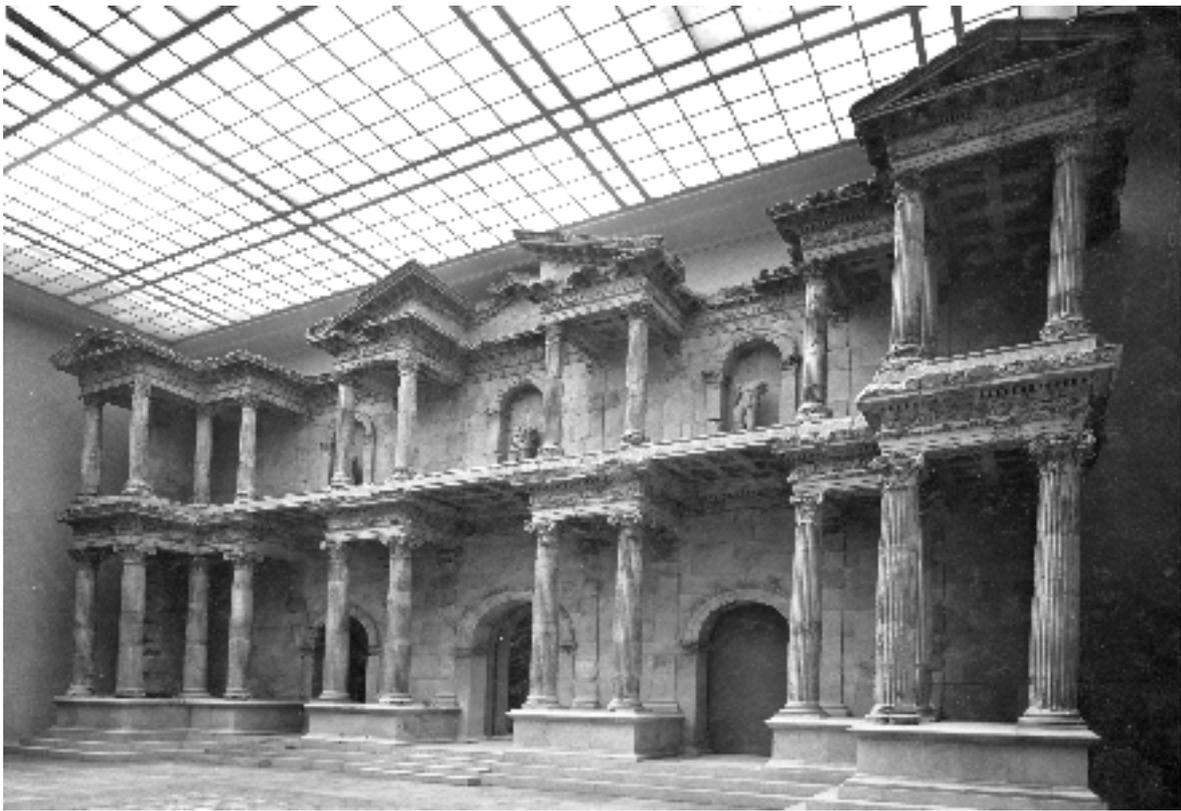
Figure 1. Reconstruction of the Market Gate of Miletus in the Berlin Pergamon Museum, c. 1930/39 (Antikensammlung Berlin, Archiv)

The monumental Market Gate of Miletus was built between c. 120 and 130 AD in the time of the roman emperor Hadrian. This manifold decorated two-storeyed building has three doorways and was the entrance to the southern market of Miletus in Asia Minor (Figure 1). It was modified several times during the centuries, e.g. in the 6th century D.C., before it was destroyed in the 11th century by an earthquake. Parts of the market gate were rediscovered in 1903 during the archaeological excavations in Miletus by Th. Wiegand and H. Knackfuss (Knackfuss, 1924). After the acquisition the discovered parts of the market gate had been transported 1908 to Berlin by ship. For the first years they were stored in

For data acquisition two campaigns - each of 4 days - were organised. Because of the specific structure of the market gate and spatial limitations inside the exhibition room (Figure 1) different photogrammetric cameras had been used. The front parts of the gate which are oriented towards the exhibition room were acquired by a UMK 1318 (Zeiss Jena) because suitable camera distances of approx. 8 m could be realised (Figure 2). Nevertheless two models had to be taken in the case of longitudinal tilt because of a ground mosaic in the centre of the room. Images of interior parts of the gate, e.g. for the extraction of vertical cross sections, upright projections and special details, were captured by stereoscopic photogrammetric cameras SMK 120 / SMK 40 (Zeiss Oberkochen).

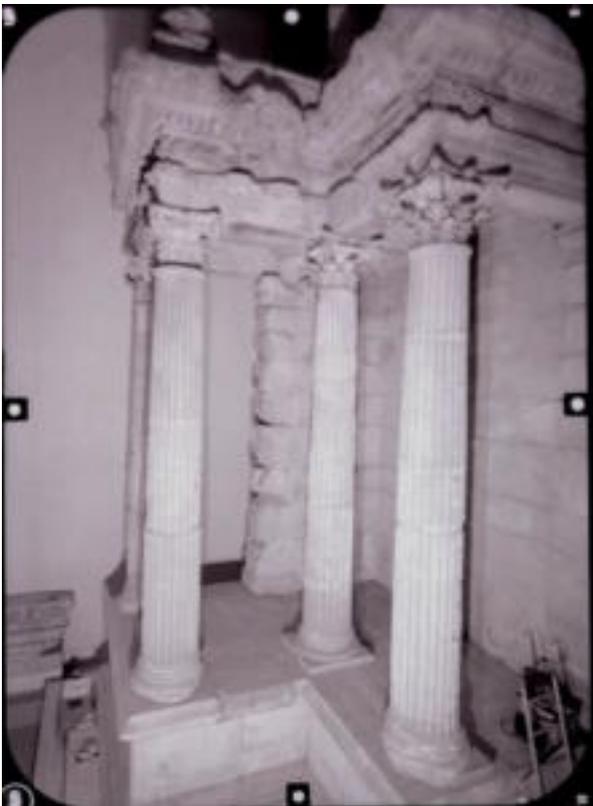
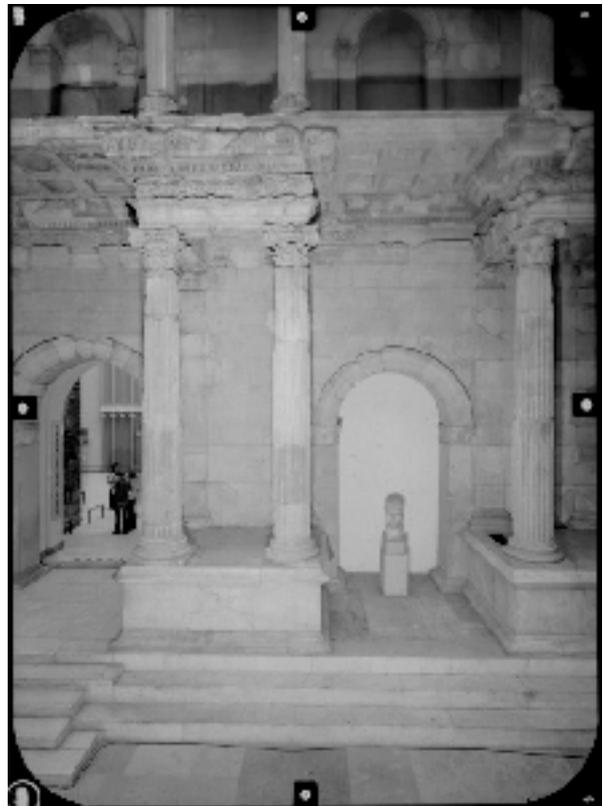
Figure 2. Original measurement images by UMK 1318, left: projecting columnar order to the left lower storey, right: front view lower storey

illustrated in Figure 4. All main contour lines of the coffered ceiling are acquired but not every ornament detail like rosettes, festons or leaf mouldings. As an example Figure 5 demonstrates one of the vertical cross sections. It contains the two-storeyed projecting columnar order on the left side (compare Figure 2).

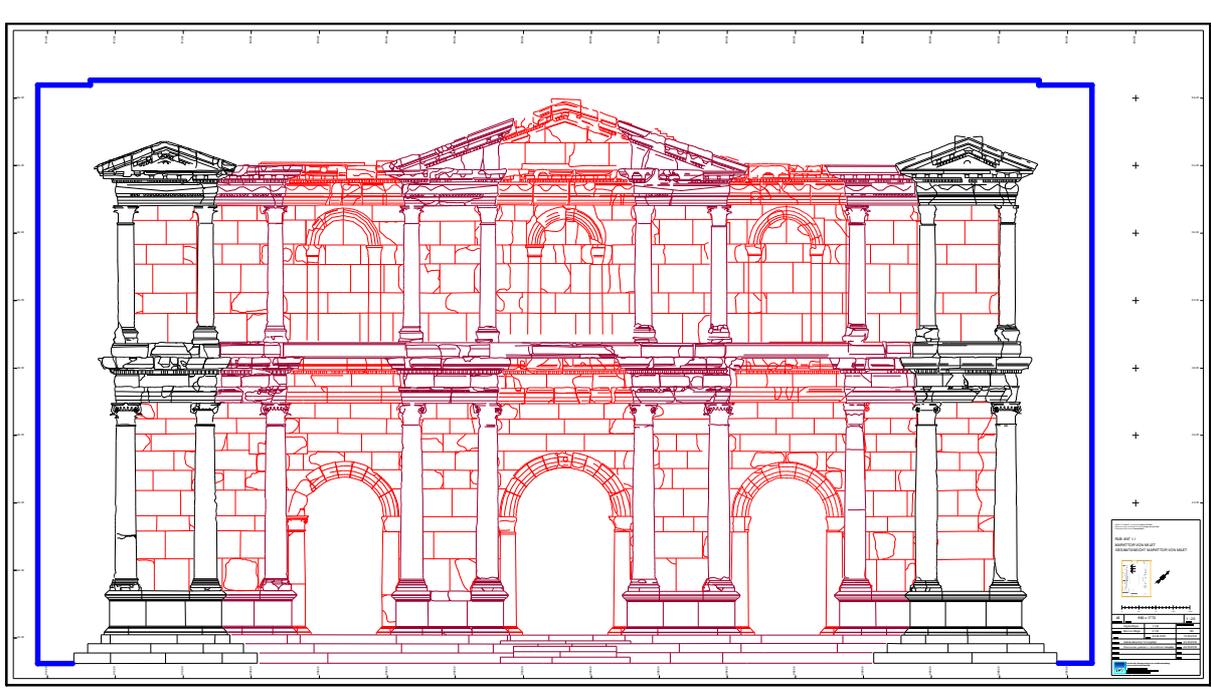
Figure 3. Photogrammetric plan of a front view of the whole market gate (thick line: contour of exhibition room)

The data were structured in different layers of a CAD system, e.g. into architectural elements like base frame, projecting columnar orders, ceilings, columns including capitals, architraves etc., as well as into different depth layers. This structure was defined in collaboration with restoration experts before starting data acquisition. Therefore, a great variety of different combinations may be created, e.g. ground data with or without coffered ceilings, or a front view of the building without columns. In principle all data were acquired digitally in 3D. Nevertheless additional analogues plans in 2D were requested by the restorers in order to draw manually different building damages into these plans while viewing directly at the respective building details. For this 2 ground plans and 2 upright projections of the ceilings of the lower and upper storey resp. were derived from the 3D data, 2 front views with and without columns, solely columns and architraves including gables, 2 lateral views and 11 vertical cross sections. Figure 3 shows the photogrammetric result in terms of a front view of the whole market gate including columns (in this case without flutes) and brickwork of the back plane. The outer thick line is the contour line of the exhibition room. Different grey values represent different depths of the architectural elements (black: front level, dark grey: middle level, light grey: back plane level). An upright projection of the coffered ceiling of the lower storey is

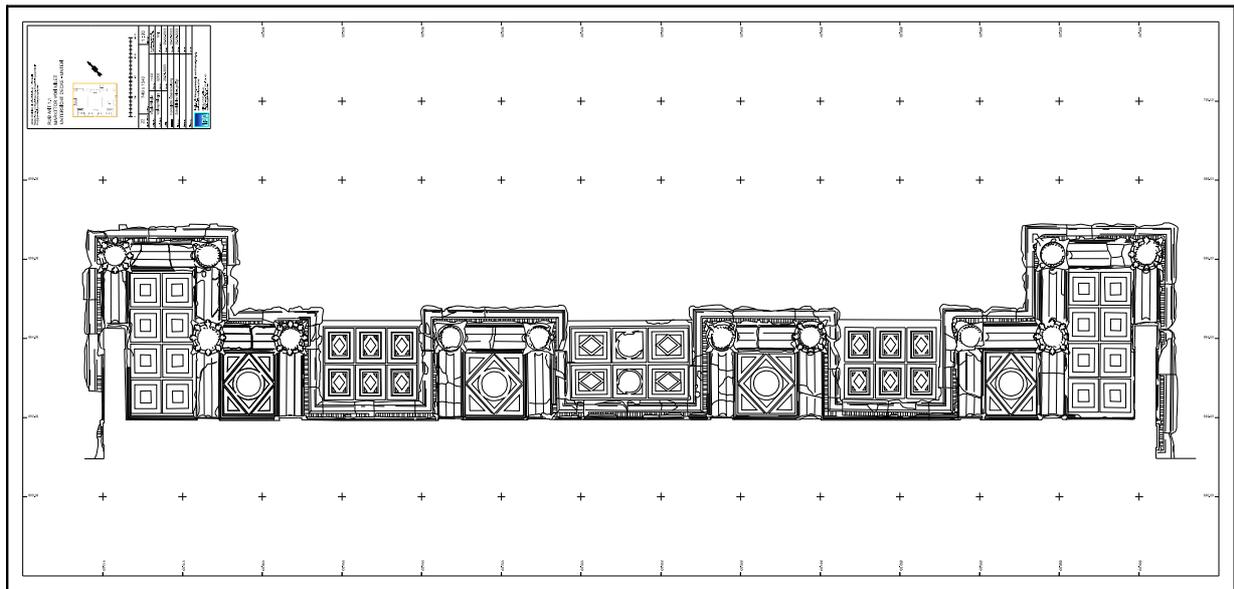
Figure 4. Upright projection of the coffered ceiling of the lower storey

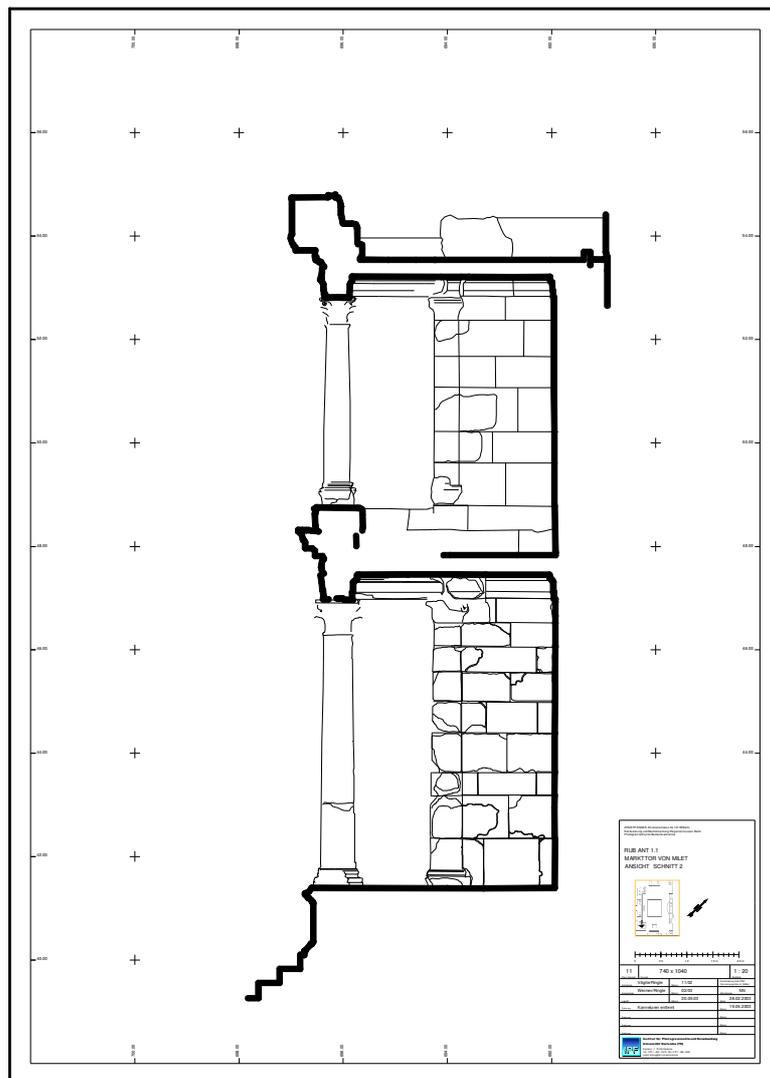
Figure 5. Vertical cross section of the projecting columnar order on the left side of the market gate

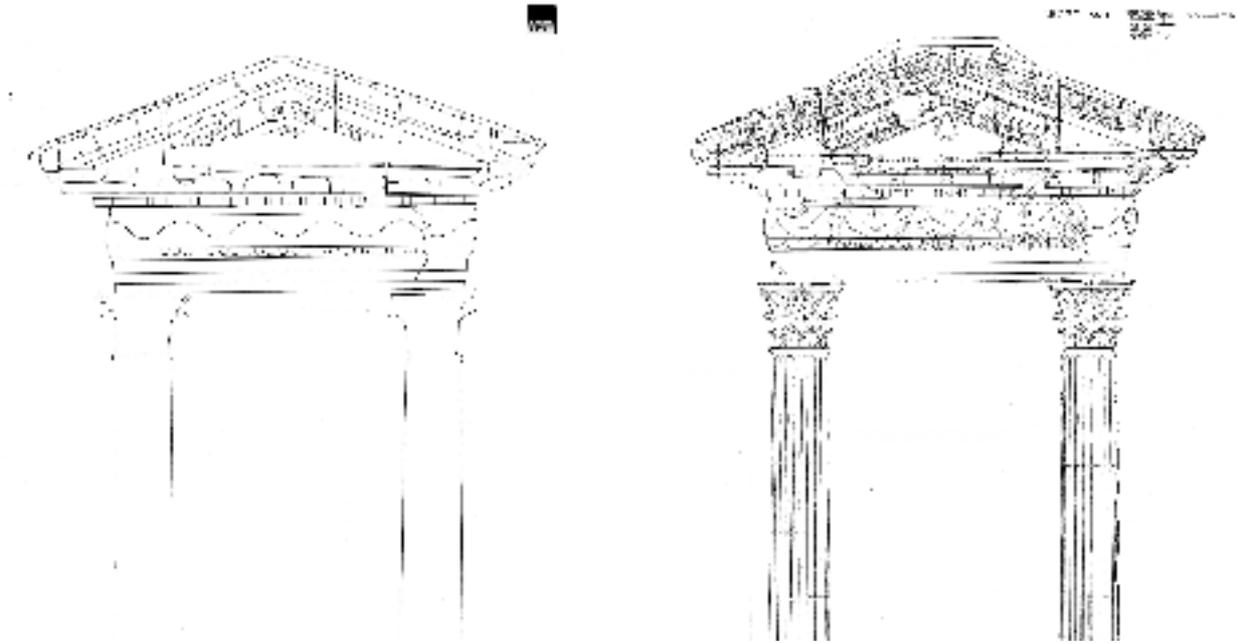
Figure 6. Original photogrammetric result (left) and completion by architects and restorers (right)

In a next step a revision and completion of the photogrammetric results has to be done by architects and restoration experts due to few missing parts which could not be captured by photogrammetry and details of ornaments which had been excluded a priori, e.g. small parts of the backside of the columns or the ornaments on the architrave. In Figure 6 the original photogrammetric data and the completion by the architects can be compared. In this case ornaments on pediment and entablature, the capitals of the columns and a part of the roof construction have been added.

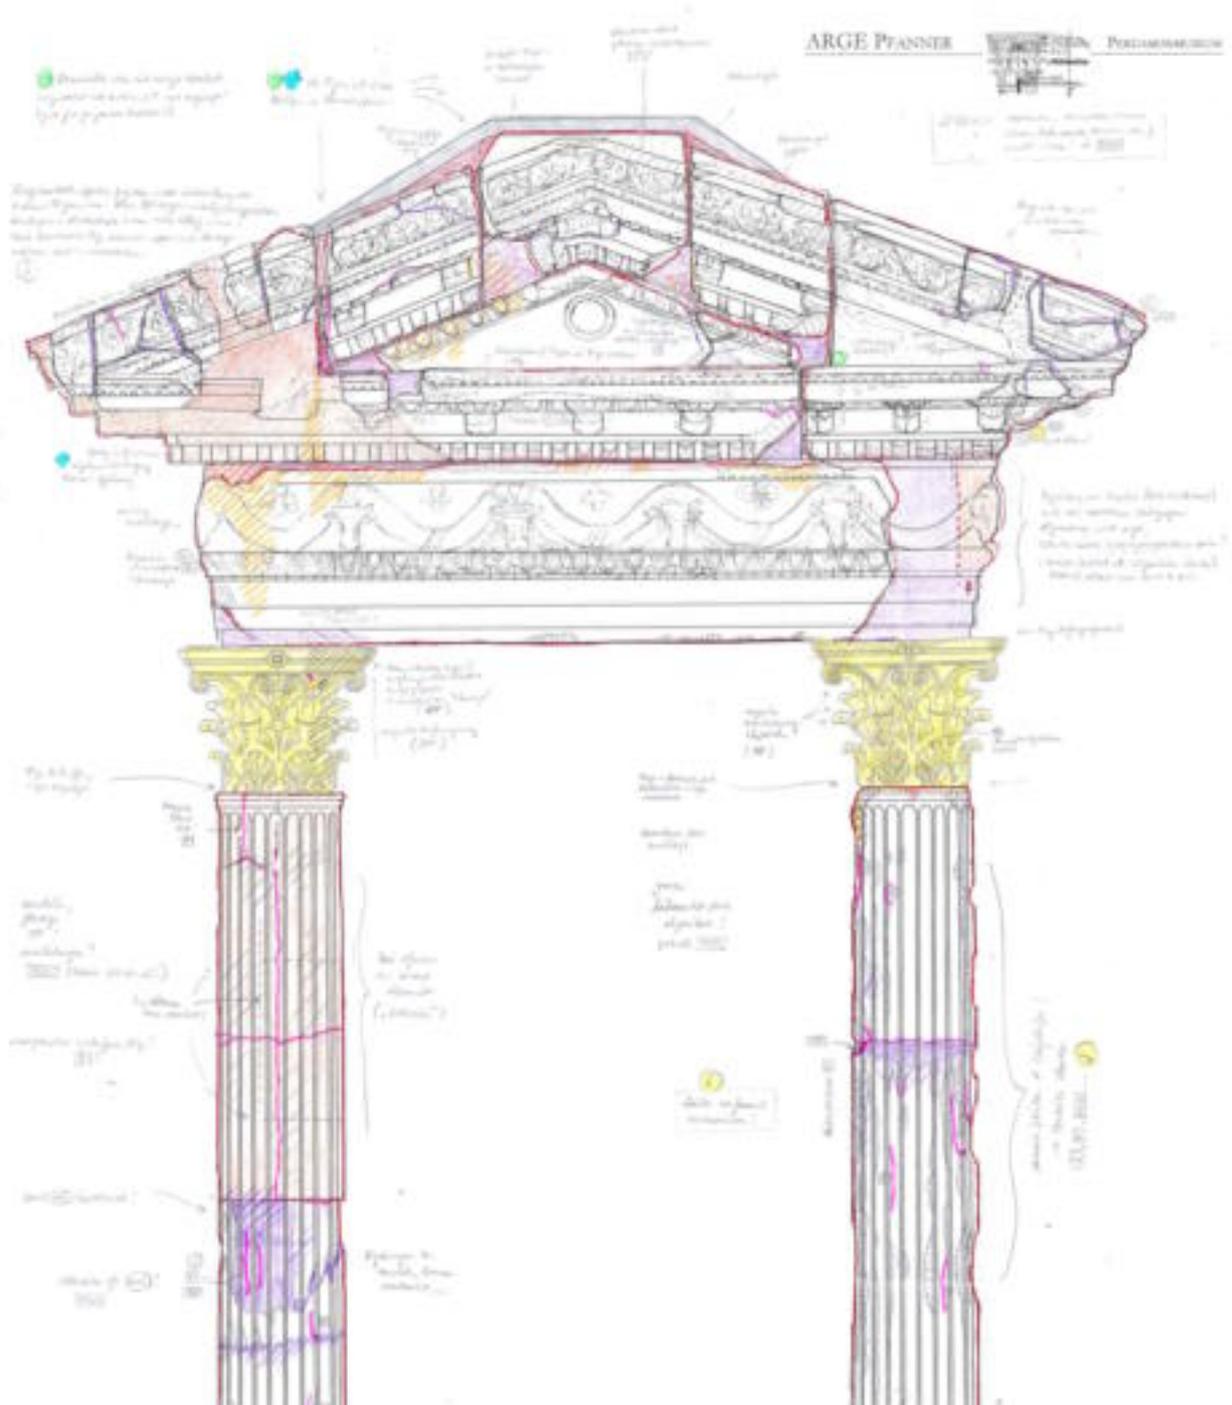
Figure 7. An example for damage mapping by architects and restorers

Subsequently a mapping of the existing damages based on the photogrammetric results can be elaborated by the restorers. It contains a specification of the material, state of preservation and comments about construction details (Figure 7). This information leads to the definition of necessary conservation activities (Maischberger, 2003).
