İZMİT SULTAN ABDÜLAZİZ IMPERIAL LODGE: DOCUMENTATION AND ASSESSMENT OF DAMAGES CAUSED BY THE EARTHQUAKE OF 1999

ABSTRACT:

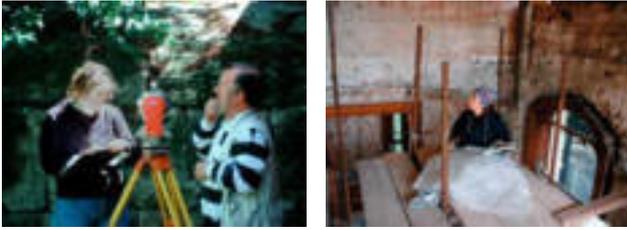
Figure 8a, 8b. Field survey and documentation.

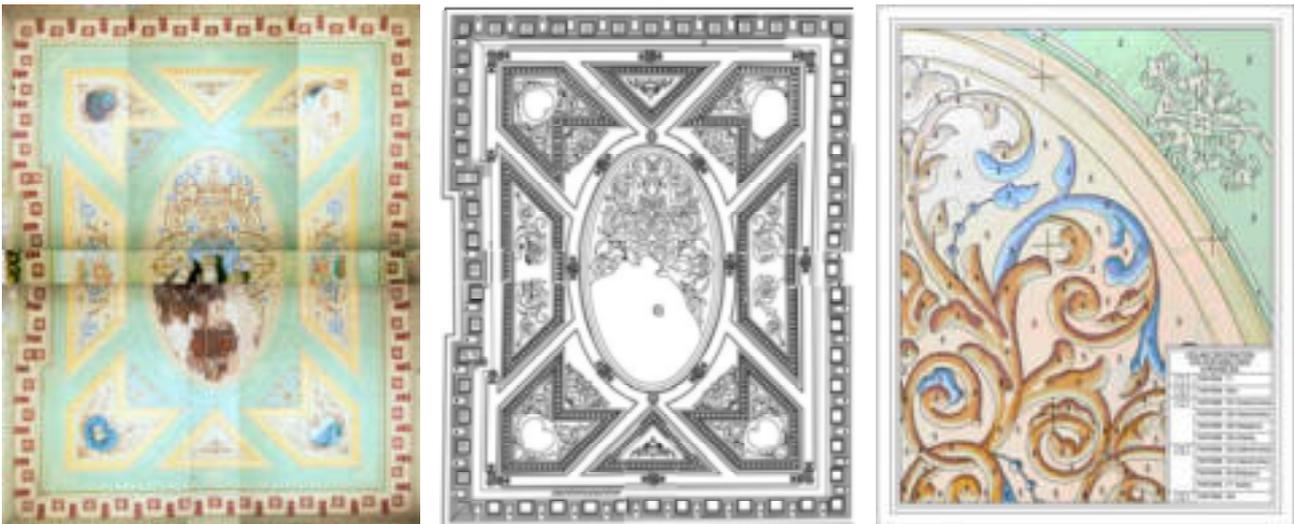
Figure 9a, 9b, 9c. Rectified photographic plan image and the drawing of Room Z03. A sample of colour analyses for Room Z03
