REHABILITATION OF THE TUNKU CANSELOR HALL, UNIVERSITY OF MALAYA, KUALA LUMPUR, MALAYSIA.

Zuraini M. A.

Department of Building Surveying, University of Malaya, 50603 Kuala Lumpur, Malaysia
zuraini_mdali@um.edu.my

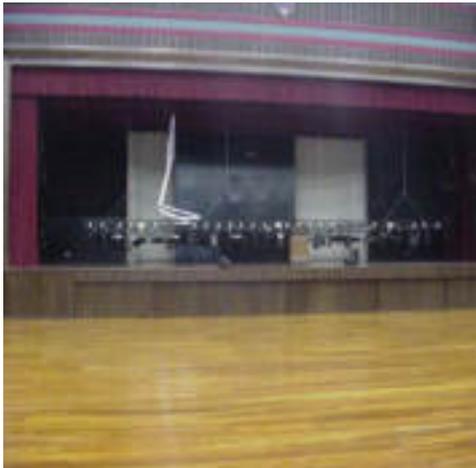
Figure 14: View of the new stage

DTC can cater for all functions required to be held in the building such as convocation ceremony, musical and stage performances, conferences and seminars, as well as examinations hall. The design input from all consultants involved ensured that the new standard established for the hall could be satisfied. This included the reconstruction of a bigger stage area with additional features such as extended and movable stage, new durable timber flooring system, timber windows with double glazing system, new design for toilets facilities, relocating the audio-visual room, and better facilities added to the hall such as the ramp, new changing areas, new electrical and mechanical system, built-in-fittings and furniture (see figure 14).

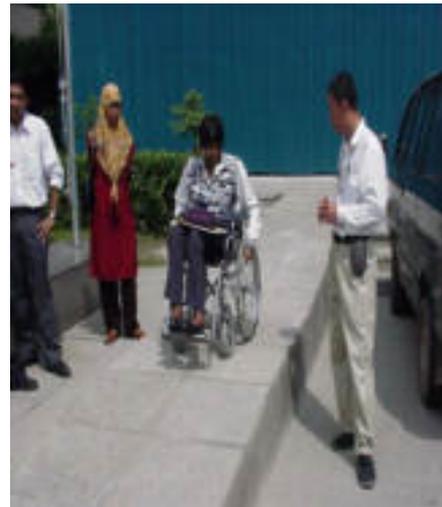
Figure 16: Assessment of ramp design during construction.

With close monitoring and constant guidance from all the project consultants, the project contractors and workers developed a very good understanding of the work involved and improved the construction methods and procedures (See Figure 16). The project was also required efficient site management and close supervision during the entire work. The success of the project was largely attributed to close supervision and high spirit of teamwork among the consultants, contractors, University of Malaya top management and the internal development and maintenance department (see figure 17 & figure 18).
